X-ray Imaging of the RTI Bump Bonded Units (Batch of 06/21/05)

A batch of 8 bump bonded units was delivered on 6/21/05 from the RTI Company. The units have been X-rayed in Fermilab Feynman Center by Bill Barker. The scheme of scanning is shown in Fig.1. Only corners of the units were scanned, as this is presumably the most difficult area to bond.

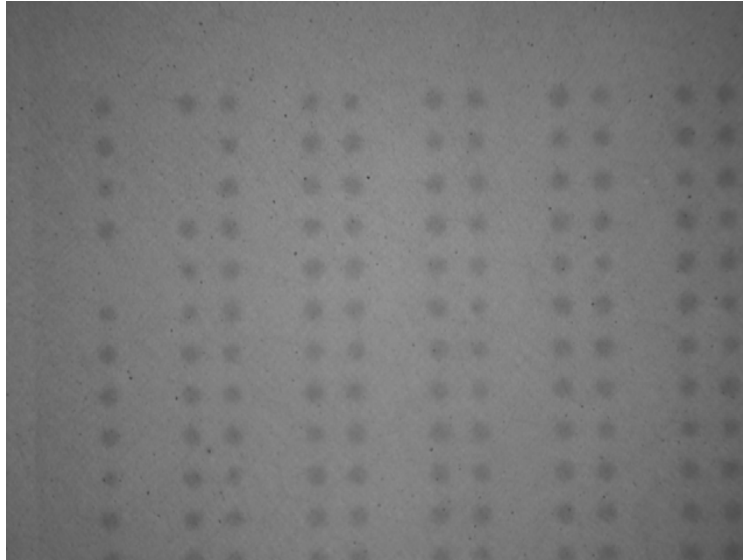
2x4#2: - 3 bumps are missing, some smaller than others at the 75b corner chip
(Fig.2)

Fig. 2 Three missing bumps at 2x4#2 unit at corner chip 75B
Some weak bumps are evident.

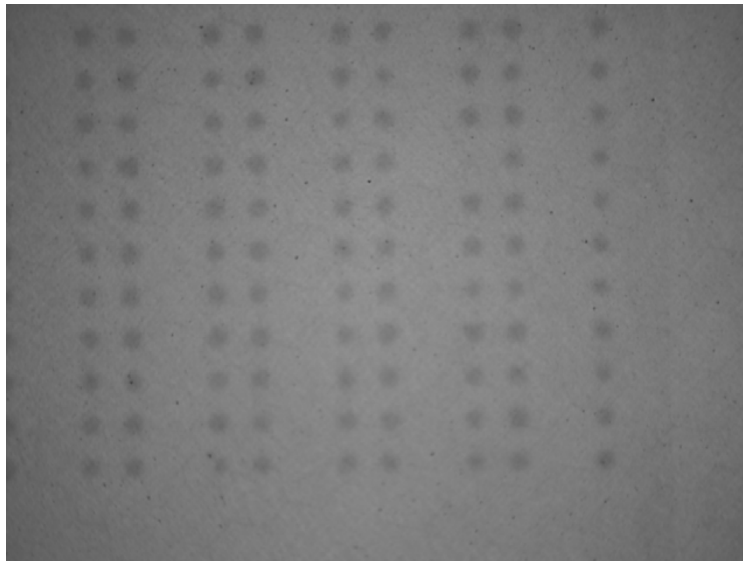
one bump missing and few weak bumps at 75A corner chip(Fig.3)

Fig. 2 One missing bump at 2x4#2 unit at corner chip 75A
Some weak bumps are evident.
